# State of Utah

### Division of Oil, Gas and Mining

### Inspection Report Minerals Regulatory Program November 9, 2010

<b>Mine Name:</b> Pine Ridge Mine	<b>Permit Number:</b> S/037/0120
<b>Operator Name:</b> Kyle Kimmerle	<b>Inspection Date:</b> 10/20/2010
<b>Inspector(s):</b> Tom Munson	<b>Time:</b> 8 AM
<b>Other Participants:</b>	<b>Mine Status:</b> Inactive

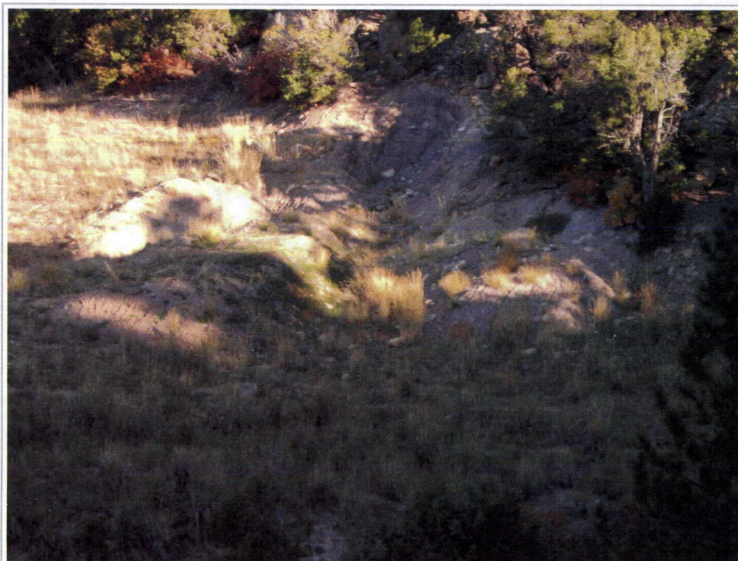
The site remains inactive and does not have ready access any more, due to closed Forest Service roads. The trench that was opened up was never filled in and what would have been considered a reclaimed mine site with limited access remains disturbed.

Trench remains unreclaimed

Depending on the outcome of conversations between the operator and the Forest Service, the Division feels this disturbance should be reclaimed if access to this site is restricted due to closed roads and lack of Forest Service approval. There is currently enough money to complete reclamation of the disturbance that exists on site.

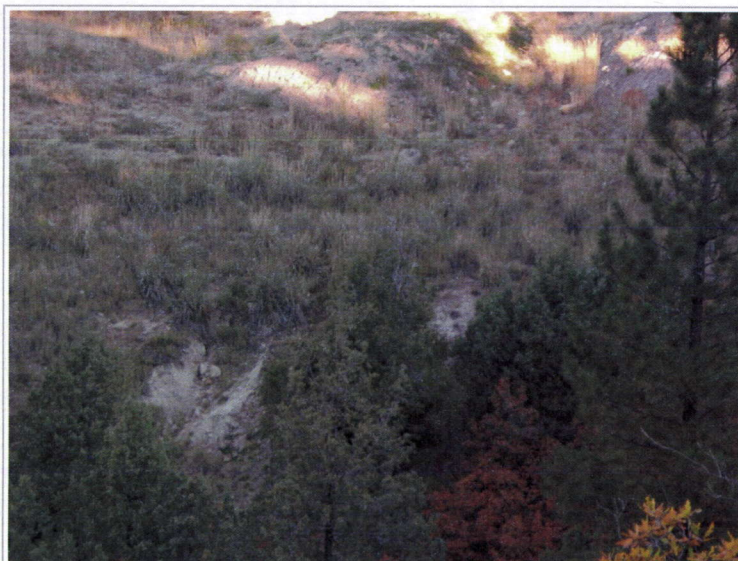
Potential additional trench
